# Flash Freezing in Fluoropolymer Bottles

APPLICATION NOTE

## Flash Freezing in Fluoropolymer Bottles

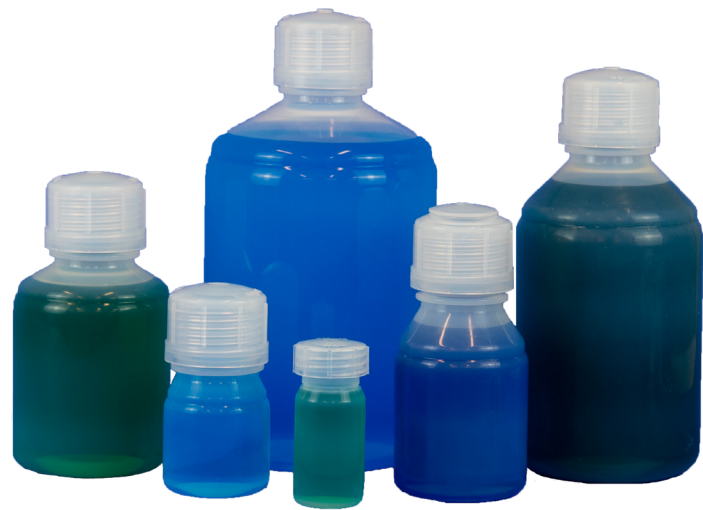
| <p><b>TEST PROCEDURE</b></p> | <p><b>Note:</b> 200 mL water remained in bottles after submersion test and was present during the integrity testing.</p> <p>Each closure was drilled, and a fitting was tapped into the closure. Caution was used to ensure the closure did not loosen or tighten during drilling and fitting installation. A pressure line was attached to the fitting, the bottle was supported in an inverted position, and was pressurized to 2 psi. After a five-minute period, the threaded area was inspected using backlighting to inspect for any water droplets. The container was then pressurized to 15 psi, and after another 5-minute period, the threaded area was inspected for any water droplets using backlighting.</p> |
